<u>RE: The Eleventh Report of the Public Administration and Appropriations Committee</u> on an Examination into the Island Wide Power Outage and Blackout that occurred on <u>February 16, 2022</u>

Document Type: Operational ProcedureDocument #: T&TEC- OP-SCGI-01Document Title: Procedure for System Restoration after a Blackout on the Island
of TrinidadIssue #: 1Issue #: 1Issue Date: 2022-03-31Rev #: 0Rev. Date: N/A

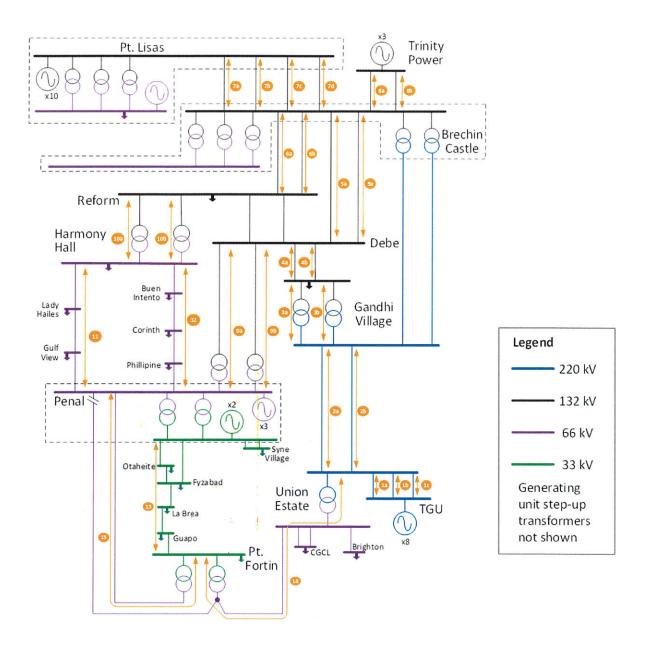
Figure A1: Suggested System Restoration Power Pathways

As immediately left (See Note 1). PowerGen Pt. Lisas (66 kV) Note 1 Suggested /Preferred[†] System Restoration Power Pathways between Generating Facilities PowerGen Pt. Lisas (132 kV) 7, 6, 10, 11 or 12. Note 1 7, 5, 4, 3, 2, 1. As per above (See Note 1) 7, 5, 9. 7, 8. 9, 4, 3, 2, 1 (See Note 1). As immediately left (See Note 1) As immediately left (See Note 1) As immediately left (See Note 1) PowerGen (33 kV) Penal Note 1 13, 14 PowerGen (66 kV) 11 or 12, 10, 6, 7. Penal 11 or 12, 10, 6, 8. Note 1 As per above (See Note 1) 9, 4, 3, 2, 1. 9, 5, 7. 9, 5, 8. 15, 14 Trinity 8, 6, 10, 11 or 12. As per above (See Note 1) 8, 5, 4, 3, 2, 1. As per above (See Note 1) 8, 5, 9. 8, 7. Note 1: Via the interbus transformers at the facility TGU As per above (See Note 1) 1, 2, 3, 4, 5, 7. As per above (See Note 1) 1, 2, 3, 4, 5, 8. 1, 2, 3, 4, 9. 14, 15 14, 13 Source Bus Pt. Lisas (132 kV) Pt. Lisas (66 kV) Penal (66 kV) Penal (33 kV) Target Bus PowerGen PowerGen PowerGen PowerGen Trinity TGU
